DOT/FAA/AR-98/53

Residual Strength Test on Stiffened Panels With Multiple-Site Damage

February 1999

Final Report

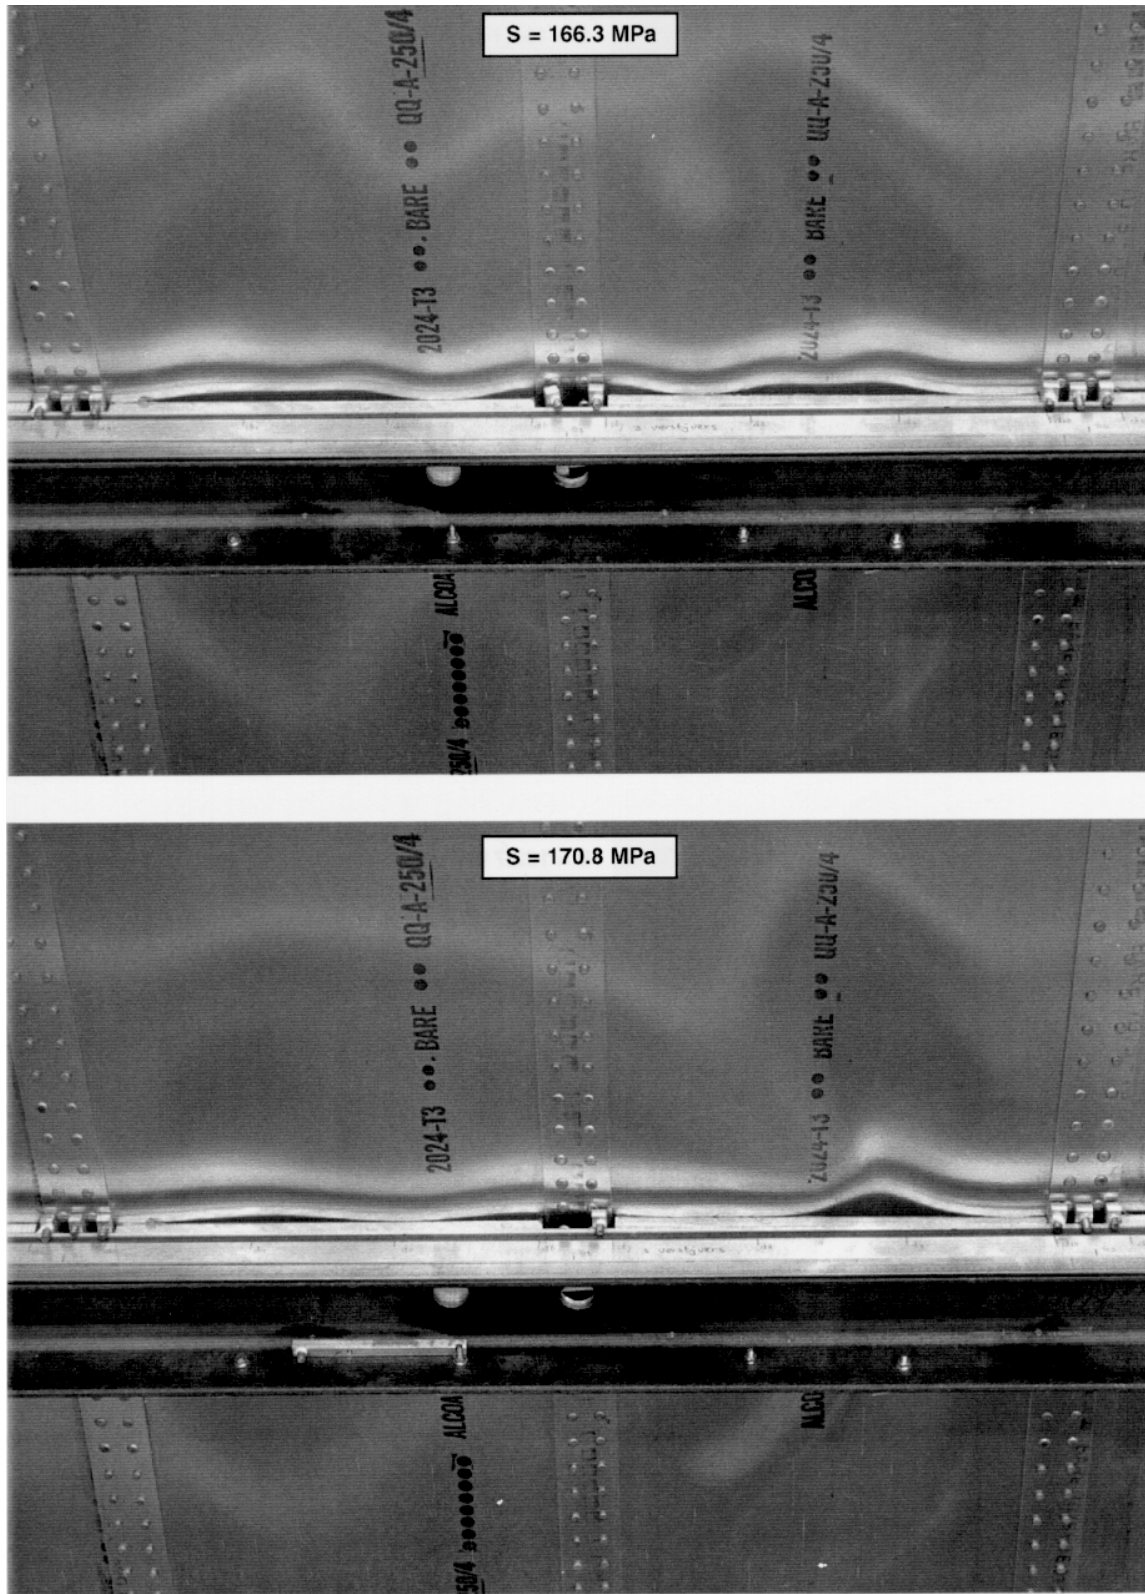
FIGURE 18. BUCKLING OF PANEL IIIb IN DIFFERENT PHASES OF THE RESIDUAL STRENGTH TEST (VIEW AT REAR SIDE OF PANEL)
